DEPARTMENT OF TRANSPORTATION

Contract #: 04-0120F4Cty: SF/ALA Rte: 80 PM: 13.2/13.9File #: 1.28**WELDING INSPECTION REPORT****Resident Engineer:** Casey, William**Address:** 333 Burma Road**City:** Oakland, CA 94607**Report No:** WIR-029527**Date Inspected:** 26-Mar-2013**Project Name:** SAS Superstructure**OSM Arrival Time:** 700**Prime Contractor:** American Bridge/Fluor Enterprises, a JV**OSM Departure Time:** 1730**Contractor:** American Bridge/Fluor Enterprises, a JV**Location:** Jobsite**CWI Name:** See below**CWI Present:** Yes No**Inspected CWI report:** Yes No N/A**Rod Oven in Use:** Yes No N/A**Electrode to specification:** Yes No N/A**Weld Procedures Followed:** Yes No N/A**Qualified Welders:** Yes No N/A**Verified Joint Fit-up:** Yes No N/A**Approved Drawings:** Yes No N/A**Approved WPS:** Yes No N/A**Delayed / Cancelled:** Yes No N/A**Bridge No:** 34-0006**Component:** OBG**Summary of Items Observed:**

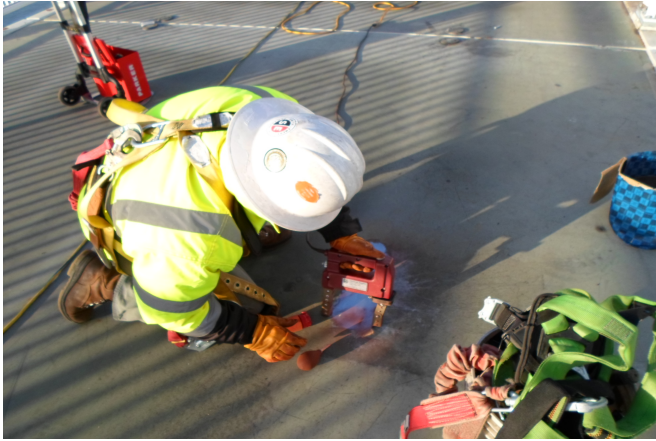
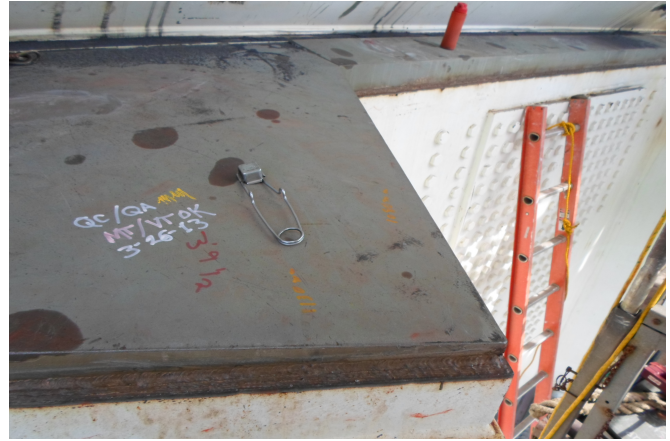
The digital photographs below illustrate some of the work activities observed on this date:
